Technical Report CHL-97-32
November 1997

Periodic Inspection of Ofu Harbor Breakwater, American Samoa

Report 1 Base Conditions

*by Robert R. Bottin, WES
Stanley J. Boc, Pacific Ocean Division*

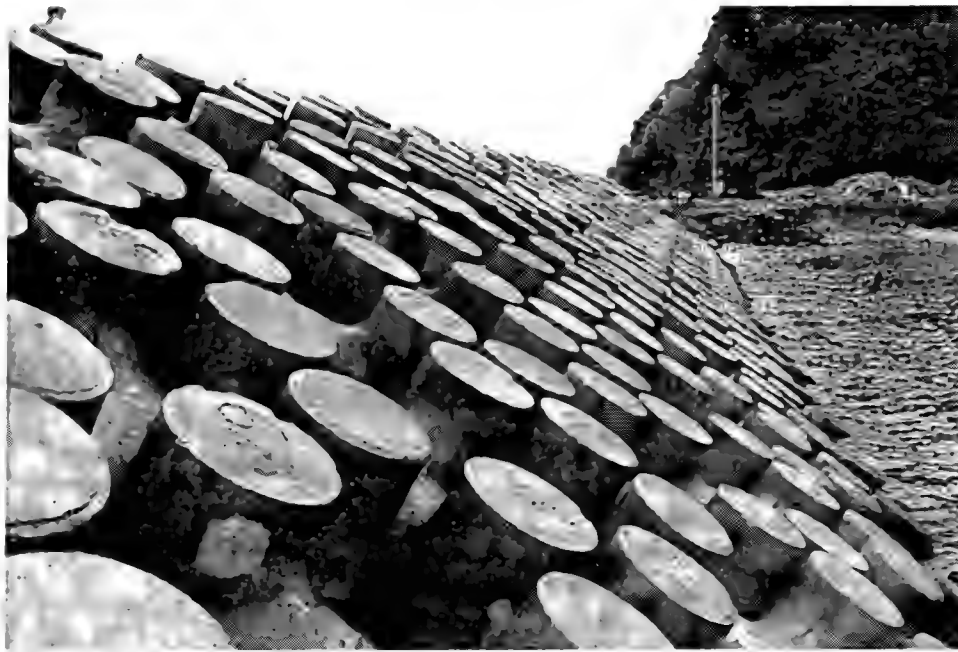
Figure 5. Tribar armor units used on Ofu Harbor breakwater

The breakwater armor consisted of a single layer of uniformly placed 4,080-kg (4.5-ton) concrete tribar units (Figure 5). The tribars originated at sta 1+75 on the seaward face of the structure and extended to sta 6+00, around the head, and then to sta 4+00 on the harbor side of the breakwater. To improve the stability of the tribars, work included the construction of a toe trench in order to stabilize the armor unit toe, and a concrete rib cap system on the breakwater crest to stabilize and buttress tribars at the upper sea-side and harbor-side slopes. The rib cap forms were fabricated and concrete poured right into the top section of the tribars (Figure 6). The crest elevation of the rib cap was +4.6 m (+15 ft), and the slope of the structure was 1V:1.5H.

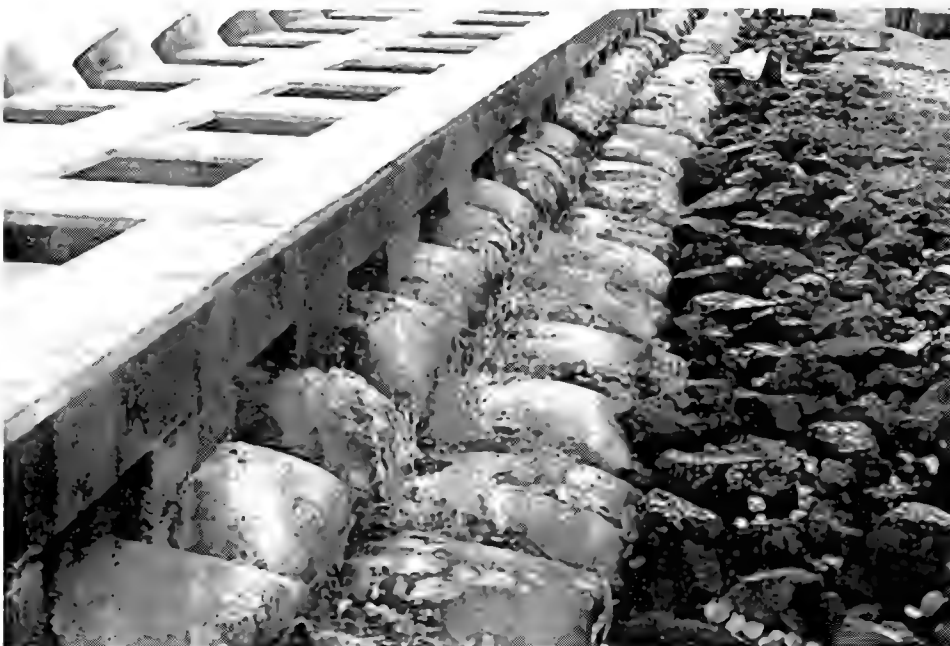
Figure 8. 2,270-kg (2.5-ton) high-strength concrete units used on harbor side of structure

In addition to the "swiss cheese block" underlayer unit, both 2,270-kg and 510-kg (2.5-ton and 1,125-lb) concrete units were formed by pumping high-strength, fine-aggregate concrete into geotextile fabric bags. The 2,270-kg (2.5-ton) units were used as a rib cap underlayer and were placed along the landfill on the harbor side of the structure between stas 1+75 and 4+00 (Figure 8). These units measured approximately $1.4 \times 0.9 \times 0.8$ m ($4.5 \times 3.0 \times 2.5$ ft) in size.

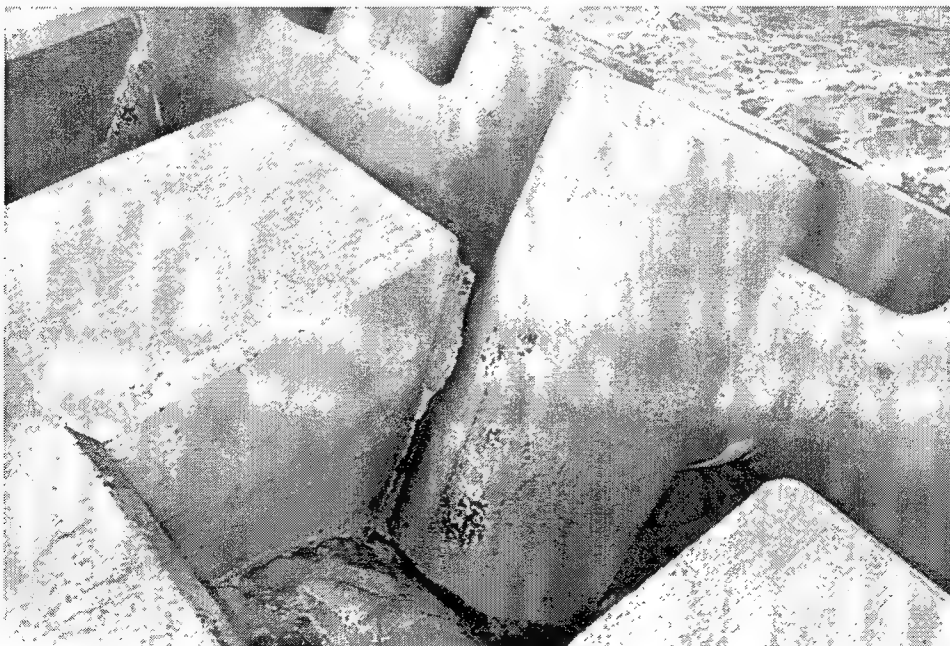
Figure 11. Separation between tribar and rib cap

On 16 October 1996, a walking survey of armor units above the waterline was conducted on the outer 130-m (425-ft) portion of the Ofu Harbor breakwater. The survey of the structure revealed no broken tribars. One sea-side tribar was slightly separated from the rib cap (Figure 11) at sta 3+05. On the

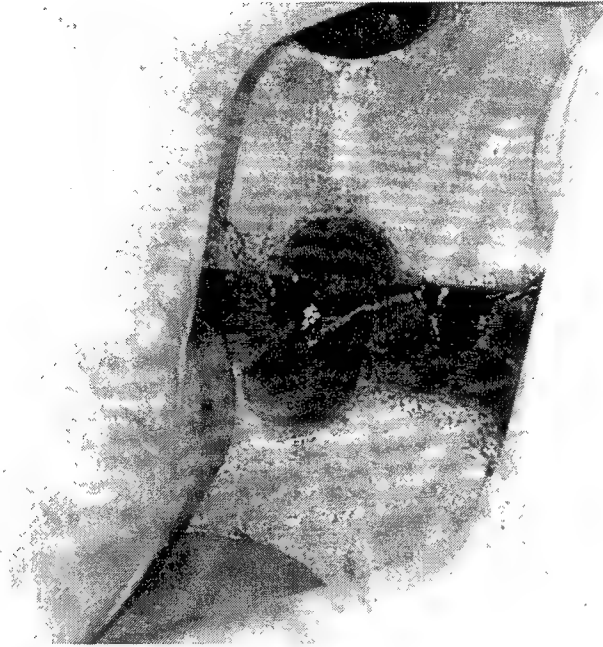
Figure 12. Separation between “swiss cheese block” underlayer units

sea side of the structure it also was noted that some of the “swiss cheese block” underlayer units had separated along the slope (approximately sta 4+50). One separation was about 20 cm (8 in.) as shown in Figure 12, with a few others about 10 cm (4 in.). It appeared that the separations were caused due to the lower underlayer units subsiding on their bottom ends. The geotextile bags had deteriorated and some spalling along the edges of the 510-kg (1,125-lb) high-strength concrete underlayer units was also noted around the head of the structure (Figure 13). In general, the breakwater appeared to be in excellent condition.

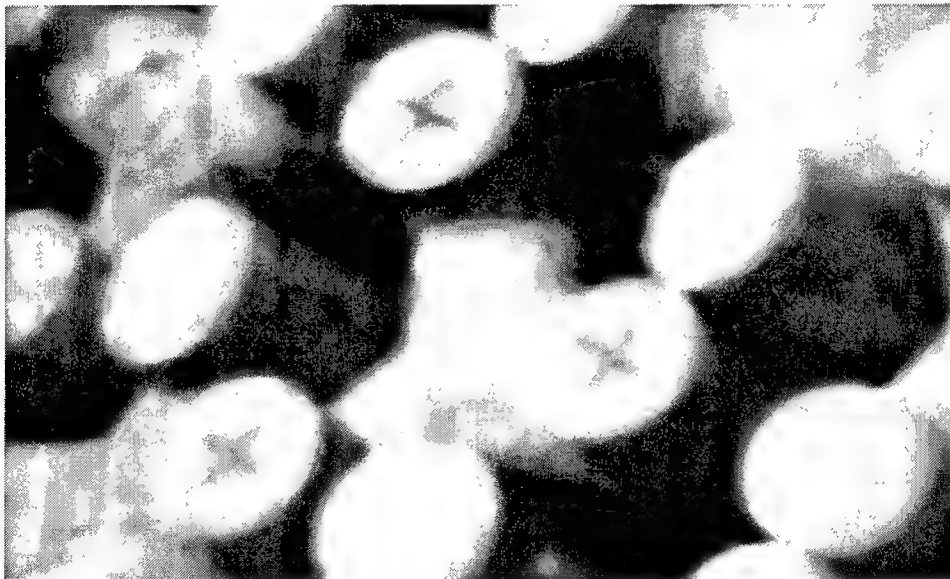
Figure 15. View of a targeted tribar (three targets established)

A total of 33 tribars were selected for detailed study. They represent an even distribution throughout the tribar field, and occupy positions ranging from near the waterline to close to the rib cap at the crest of the structure. These armor units (tribars 101-133) were painted with three targets (Figure 15). The target number is followed by an A, B, or C. Three targets on an individual tribar allow for very precise measurements depicting individual armor unit movement. Twenty additional tribars (units 19-38) were painted with a single target to serve as photogrammetric control points, as well as to be used to detect armor unit movement during future ground surveys. A 0.64-cm (1/4-in.) hole was drilled at the center of each target to mark the survey points for subsequent surveys. Locations of the targeted tribars are shown in Figures 16 and 17. Positions and elevations of the targeted tribars obtained during the October 1996 survey are presented in Table 1.
